# The Buzludzha Conservation Project: The Choice to Take Action

Submitted by sharragrow on 23 Feb 2024

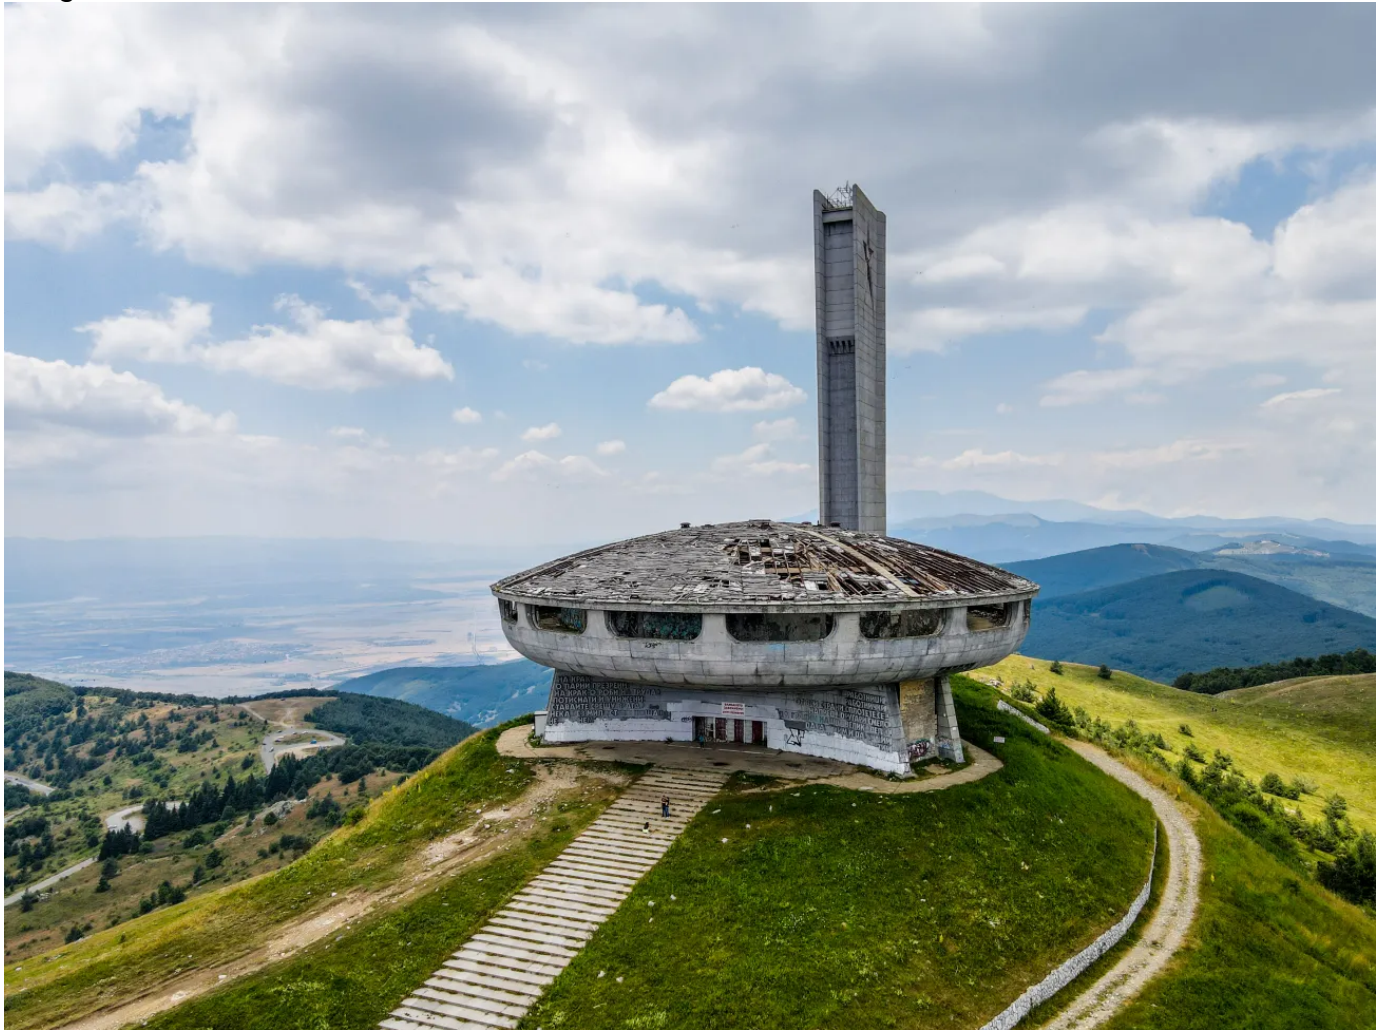
*The [Buzludzha Monument](#) was opened in 1981 to commemorate the 90th anniversary of the Buzludzha Congress, which later led to the establishment of the Bulgarian Communist Party. It is a project of the distinguished Bulgarian architect Georgi Stoilov (1929-2022) and stands at the top of the historically significant Hadzhi Dimitar (Buzludzha) peak in the central Balkan Mountains, with an altitude of 1,432 meters.*
